Exhibit 104

From: Rob Hawk
To: tac@san.rr.com
Date: Tue, Sep 25, 2007 5:36 PM
Subject: Re: Fwd: Re: Soledad Mountain Road water line/letter to customers

Sewer/Water Infrastructure Management

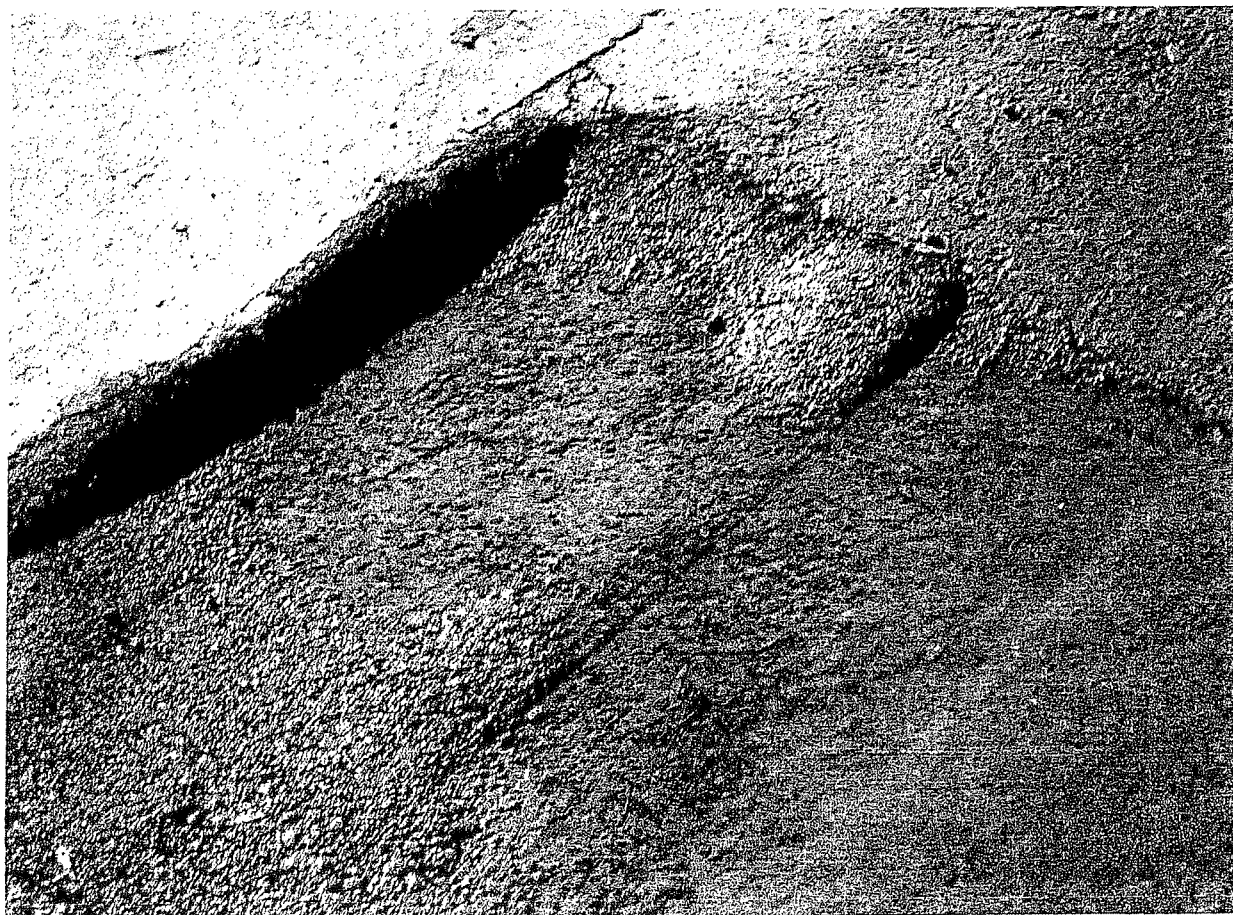
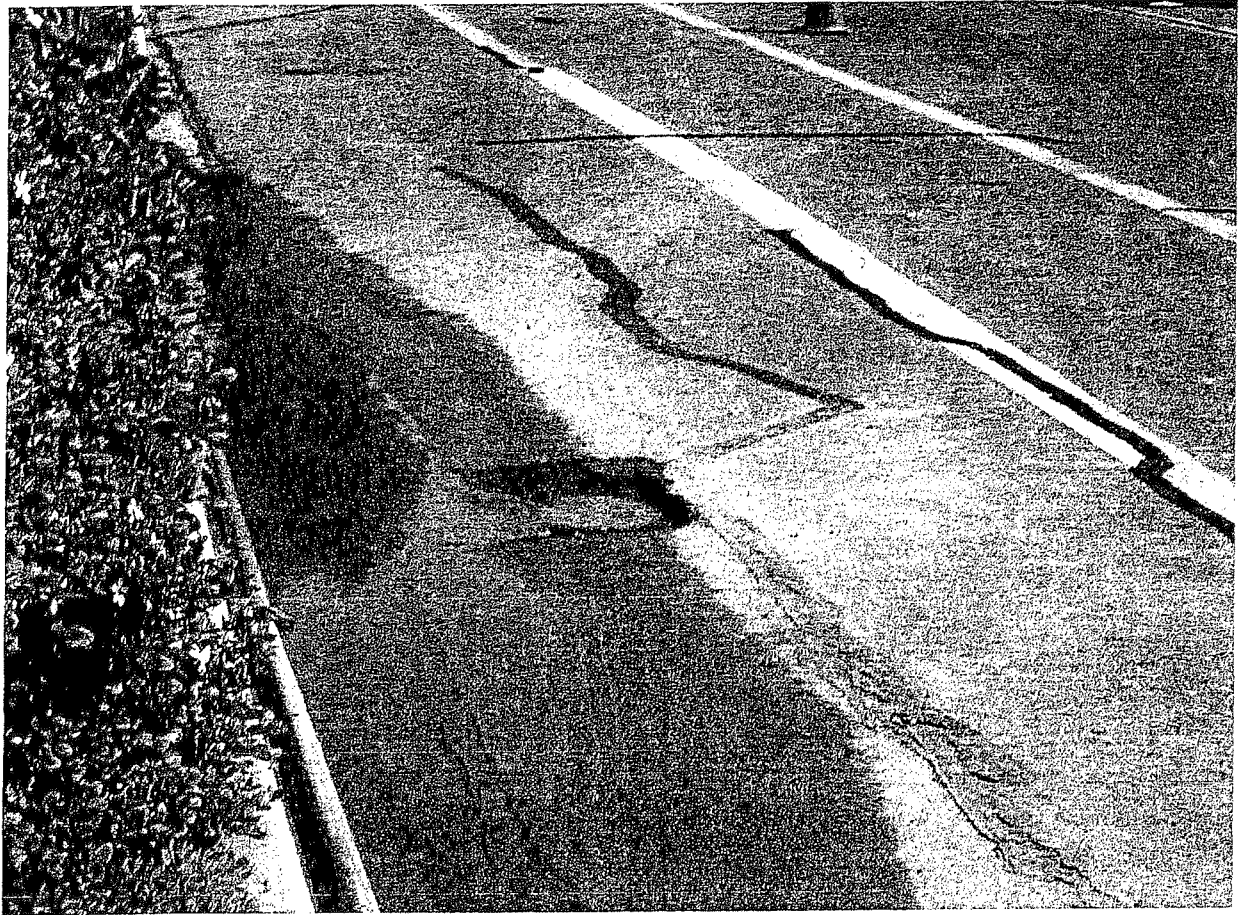
The large trucks traveling by are causing large sink holes in the new repair areas these are in front of 5695 soledad mtn rd. large amounts of water from the gutter is seeping into the street. can it please be repaired to keep any further damage to the street and surrounding areas. this large hole is over the gas line repair.

> Mr. Crabbe: Contractors should be on your road today working on
> sealingthe pavement. Road Works Inc., the crack sealers, should
> be at the site
> now. Be sure to call the hotline number; Carol can probably get
> back to
> you faster than I can.
>
> Rob Hawk
>
> >>> <tac@san.rr.com> 9/20/07 6:49:42 AM >>>
> The large gaps in the road and along the curb on the even side of
> the
> road need to be sealed. It rained last night and will rain more
> next
> two days. There's another gas leak in front of 5695 soledad mtn
> rd. I
> called gas company last night they are to come out today.
>
> ----- Original Message -----
> From: Rob Hawk <RHawk@sandiego.gov>

FYI _ I just came from the job site. nothing is serious. As I suspected, the SDG&E patch around their connection was not done good. It is a 2ft X 1 ft trench. it seems that a car passed over it and the trench settled /deflected. The SDG&E patch is not in the travel lane or the bike lane. It is located in the car parking lane. The person who sent the photo was outside and we talked about it.

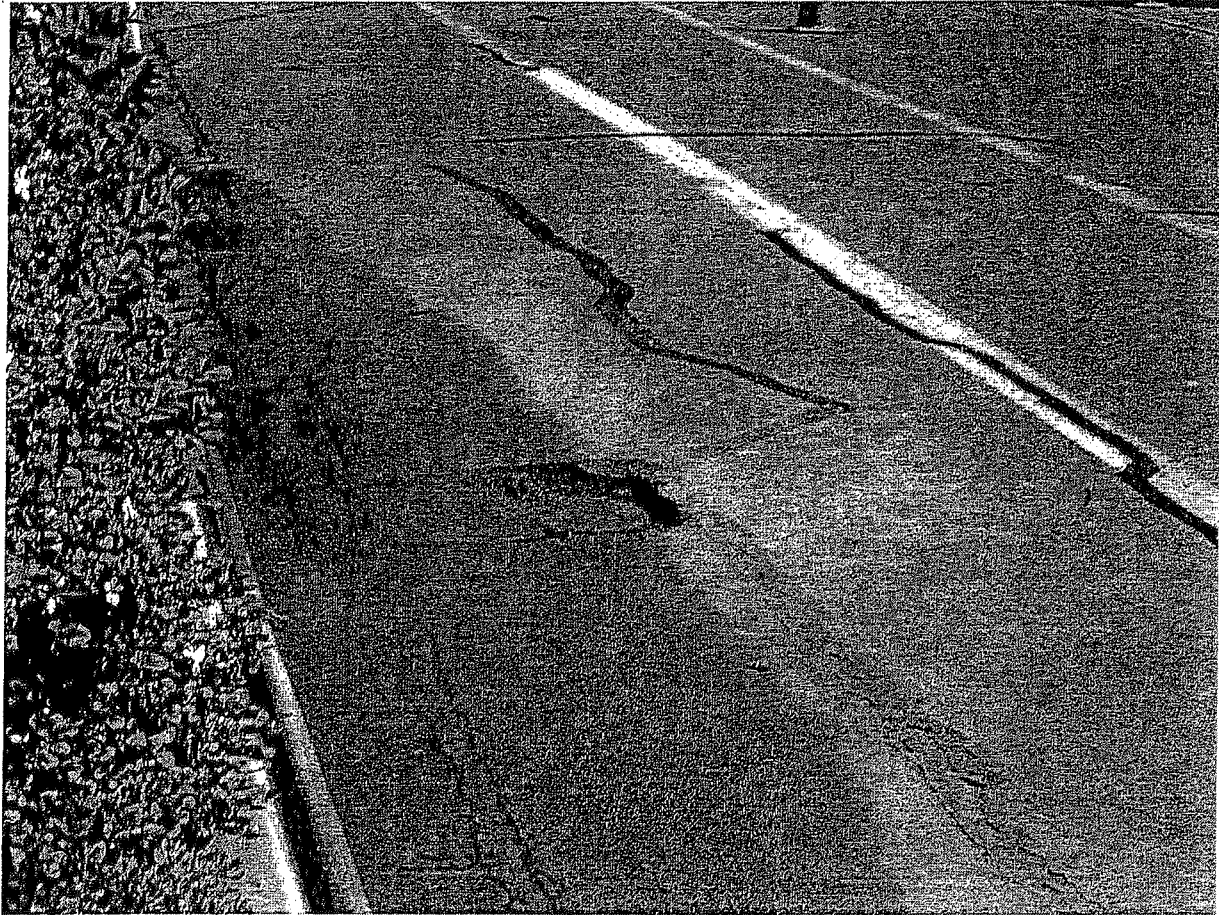
The large trucks traveling by are causing large sink holes in the new repair areas these are in front of 5695 soledad mtn rd. large amounts of water from the gutter is seeping into the street. can it please be repaired to keep any further damage to the street and surrounding areas. this large hole is over the gas line repair.

Not sure if this is water, gas, or ?? at this point, can we have a crew out asap to patch up the pothole.
